Number 1: 312 S. TALBOT STREET - LEONARD FUNERAL HOME

Number 4: 305 S. TALBOT STREET - THE MARYLAND NATIONAL BANK

Number 6: 101 N. TALBOT STREET - THE LAUNDROMAT

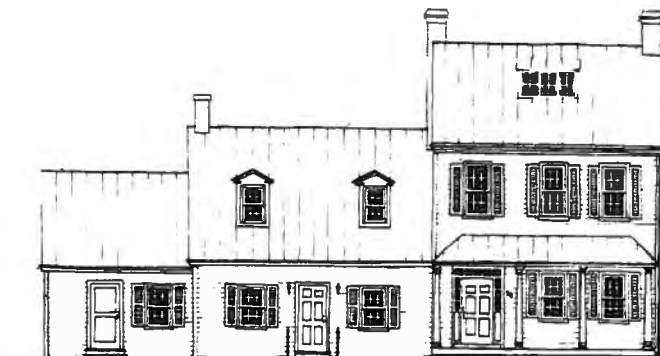
312

This house has been well maintained and preserved over the years and is a beautiful example of mid-nineteenth century domestic architecture. The existing front porch is probably more appropriate for the house today than the porch shown in the sketch made of the early photograph. Similarly, the early chimney on the south wall of the main portion is not missed. Shade trees, once in front of this building would contribute significantly to the character of the street if they could be replanted.

The sketches of the house as it is today and as it was earlier in this century are included in this study to show the building at two periods. The different porch designs greatly affect the appearance of the house. The existing design is very appropriate and supports the character of the Historic Area. If however, a future owner were interested in changing the appearance of the house the early photograph offers an alternative. The maps suggest that at one time there were no porches at all.

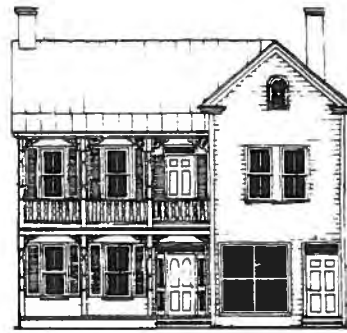
310

In recent years a great deal has changed. The second floor gallery has been removed, the porch enclosed and a heavy mansard hood built over the shop entrance at the north side of the building. The projecting gable end has lost its arch top window and the original windows on the second floor have been replaced by a pair of windows with very different proportions. Large picture windows with colonial grids have replaced the windows on the first floor and new siding with a narrow corner trim has taken the place of the original weatherboard and cornerboards. The chimney caps and hood are gone.

Every effort should be made to preserve and maintain this house. The foundation and basic framing members should be checked and repaired if necessary. The wooden porch floor framing and decking could be also checked and repairs made where necessary.

Each of the building components, the doors, windows, siding, trim and masonry elements should be recorded, inspected, maintained and repaired as required.

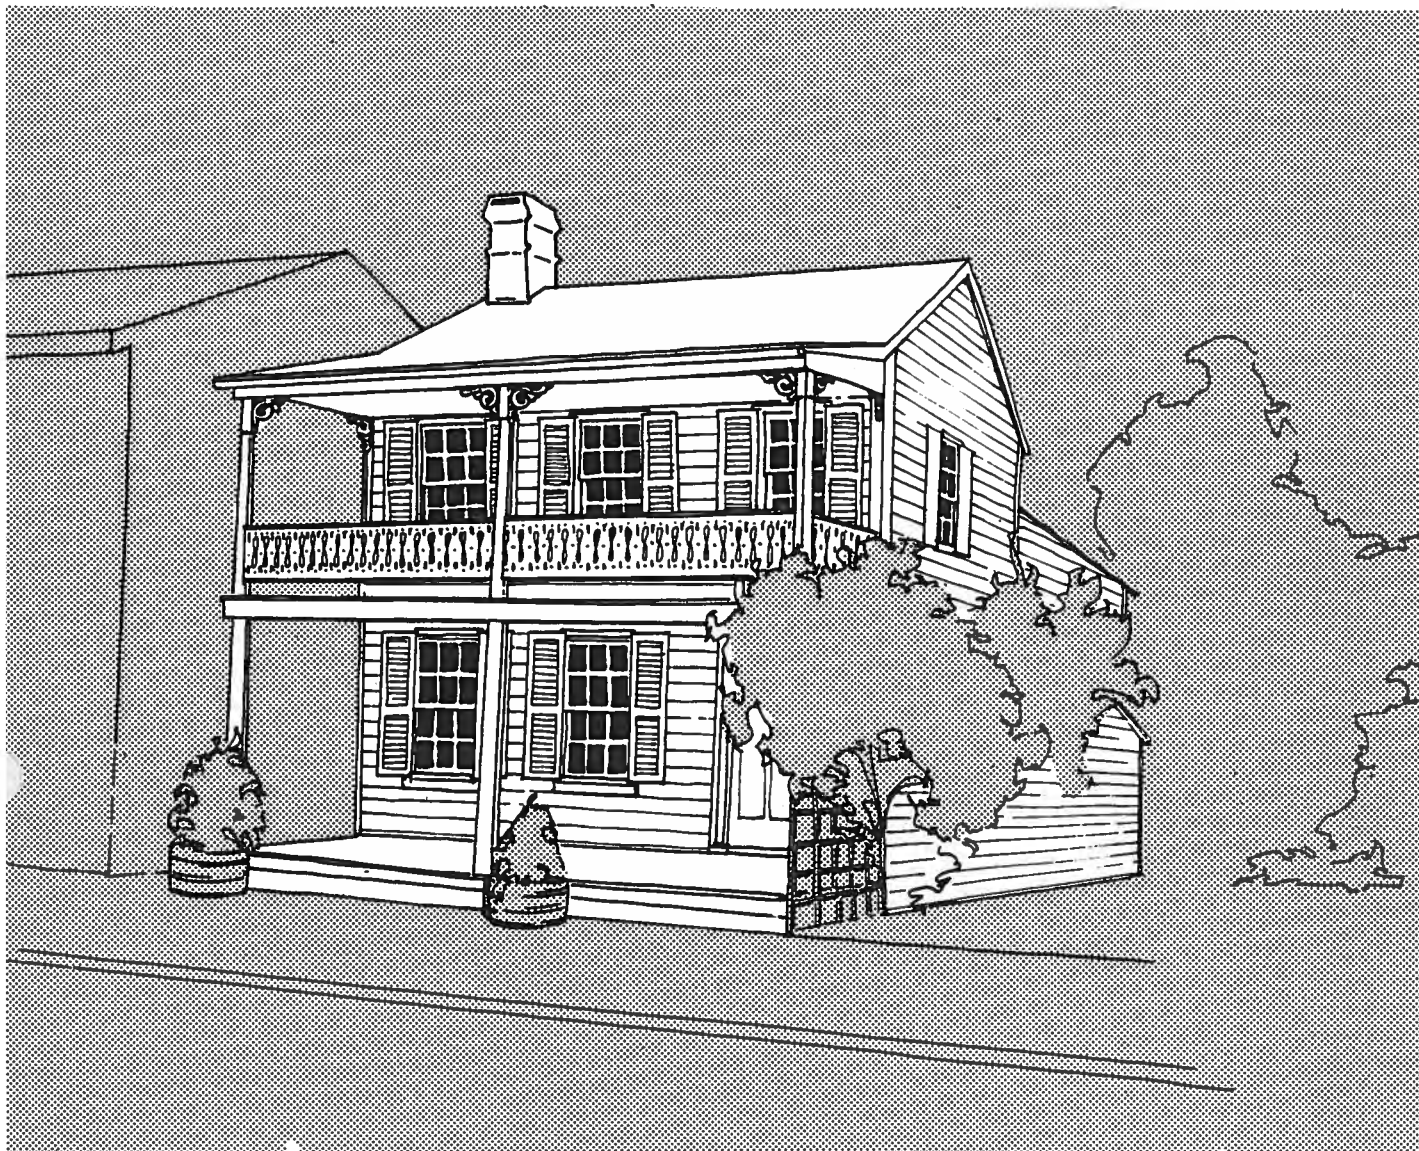
2 SOUTH TALBOT

is drawing shows the building as it appeared in 1987

The aluminum storm/screen door could be replaced by a simple door with painted wood rails and stiles that would not detract from the design of the front door.

If a brick sidewalk is built in front of this house a brick step the full length of the front porch might be included.

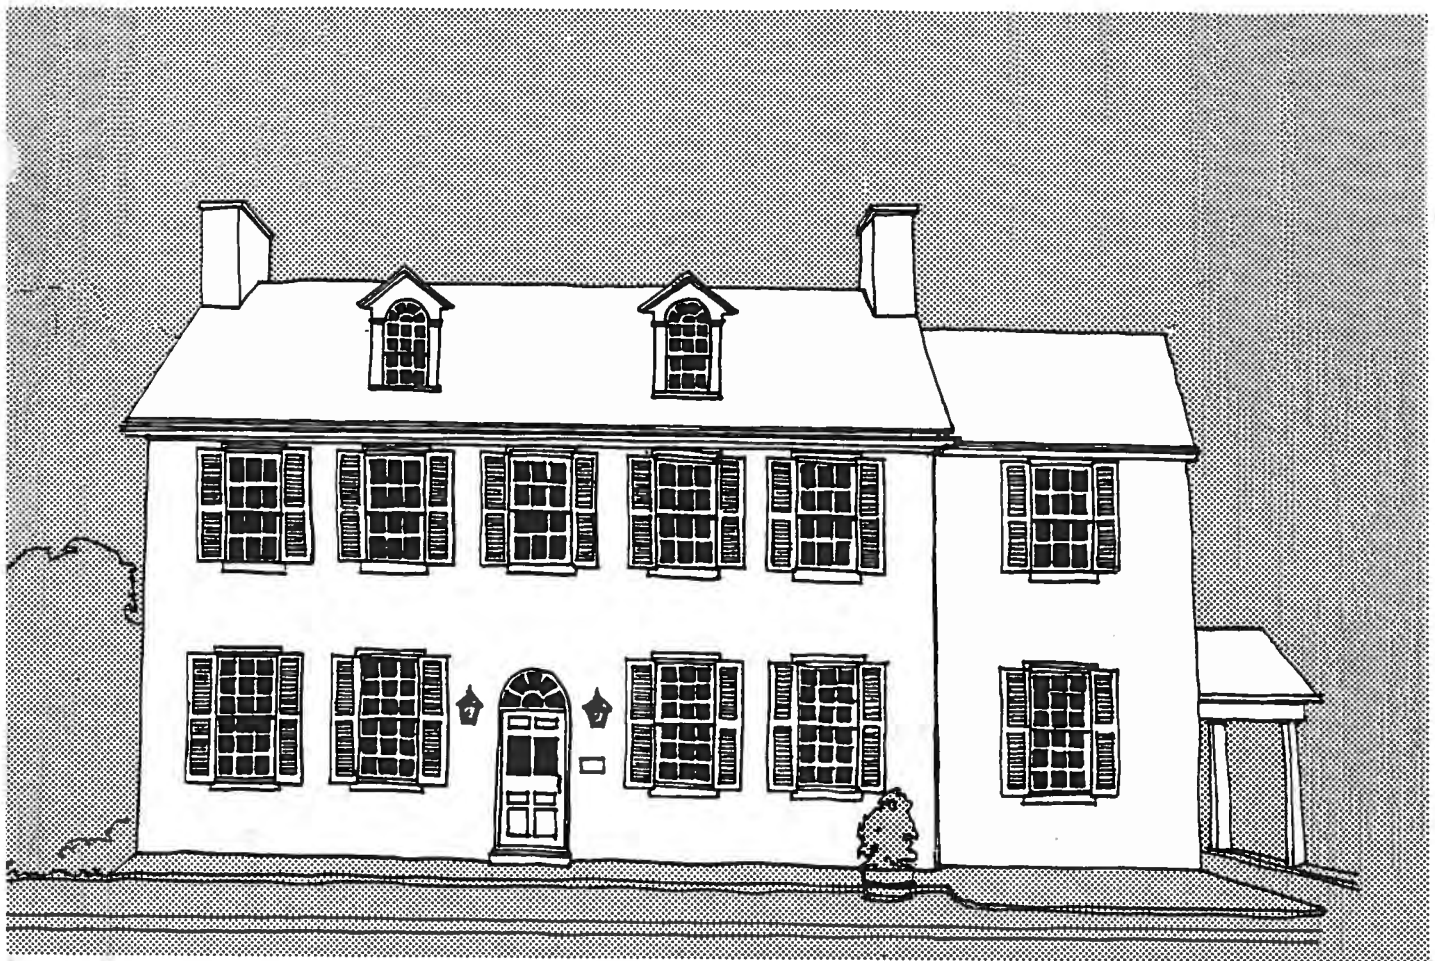
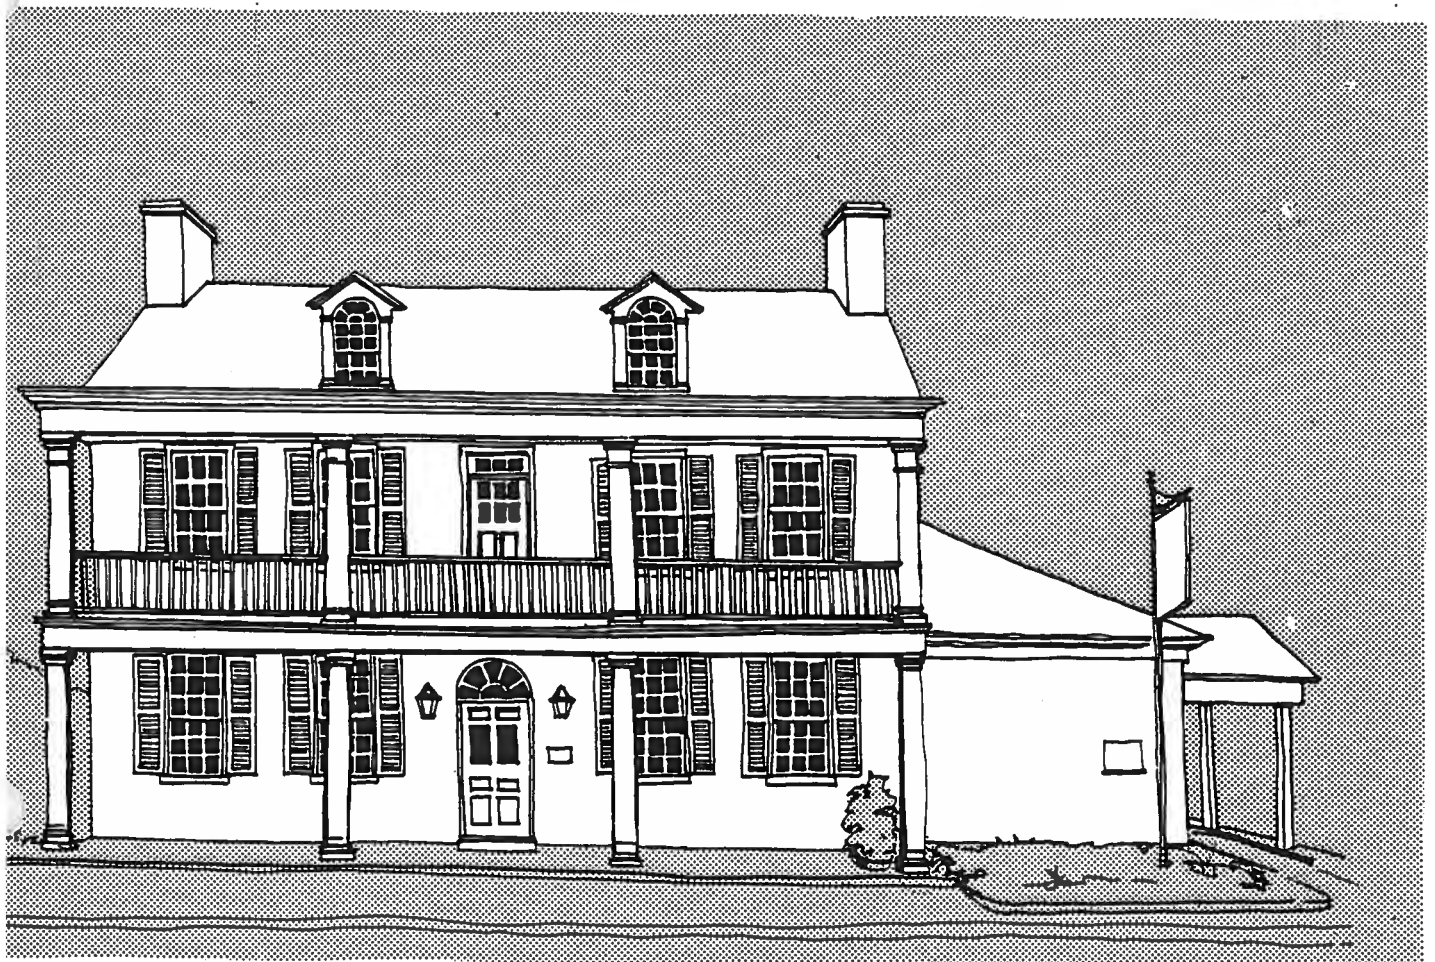
305 SOUTH TALBOT

was flaking and falling off. The original oak floor joists and rafters were rotted badly at their ends. The two-story front porch and gallery were unsafe.

The present configuration of the building seems to serve its purpose quite well. In the future, if desired and if good photographic evidence were found, the second floor gallery could be reconstructed. The early maps support the claim that the original building was built without a porch of any kind.

The excellent maintenance and preservation of the building should continue and care should be taken not to add detail or elements that were not part of the original building.

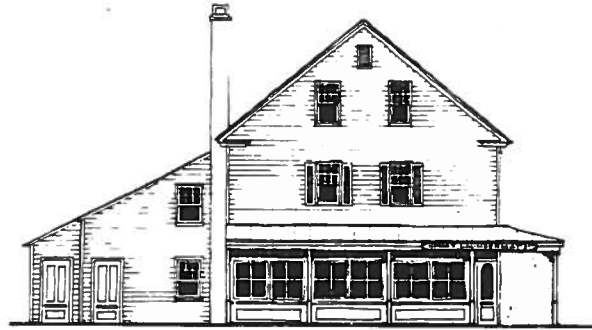
101 N

At the present time, the building has deteriorated considerably but provides an essential service to both the local community and visitors to the harbor.

This building is not in the best of condition. If possible a number of steps should be taken to insure its preservation. Its position and current use are important to St. Michaels.

The foundation could be checked and any necessary repairs done. The corner porch could be rebuilt to extend across the entire facade of the corner building on both Talbot and Cherry.

The building complex could be re-clad in painted wood weatherboard with appropriate trim to match what was used on the original buildings. Trim could be used to mark the division between the two main buildings. When required, the roofs could be recovered with seamed metal.

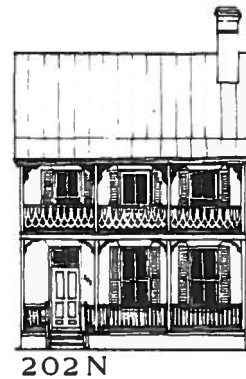
This house is presently vacant. It is a good example of a small masonry, two-story house that was probably built in the third quarter of the nineteenth century. An early photograph shows the house as it appeared before it lost its porch and gallery. If it were possible to repair this house and reconstruct its porch and gallery, it could continue to contribute greatly to the character of the Historic Area.

The brick walls of the house show signs of repair and change over the years. The pockets for the porch beams can be seen. A three course wide belt marks the second floor on the front of the house only. Single brick jack arches span the openings for the door and windows.

The house should be repaired, maintained and preserved. The front porch and gallery should be reconstructed.

The foundation and floor structure should be checked and repaired as required.

The original windows and doors should be carefully preserved and repaired where required. The missing window or door could be built to match the original ones.

When required, the roofing could be replaced with shingles with a texture similar to those seen in the old photograph.
